Clean Harbors Environmental Services, Inc.
2247 South Highway 71
Kimball, Nebraska 69145
308.235.4012
www.cleanharbors.com

Re: August 18th – August 19th, 2014 EPA Inspection
EPA ID Number: NED981723513

The purpose of this letter is to respond to the Notice of Violation dated August 19, 2014 (see Attachment One). Those alleged violations are listed below followed by the Clean Harbors Environmental Services, Inc. (CHESI) response.

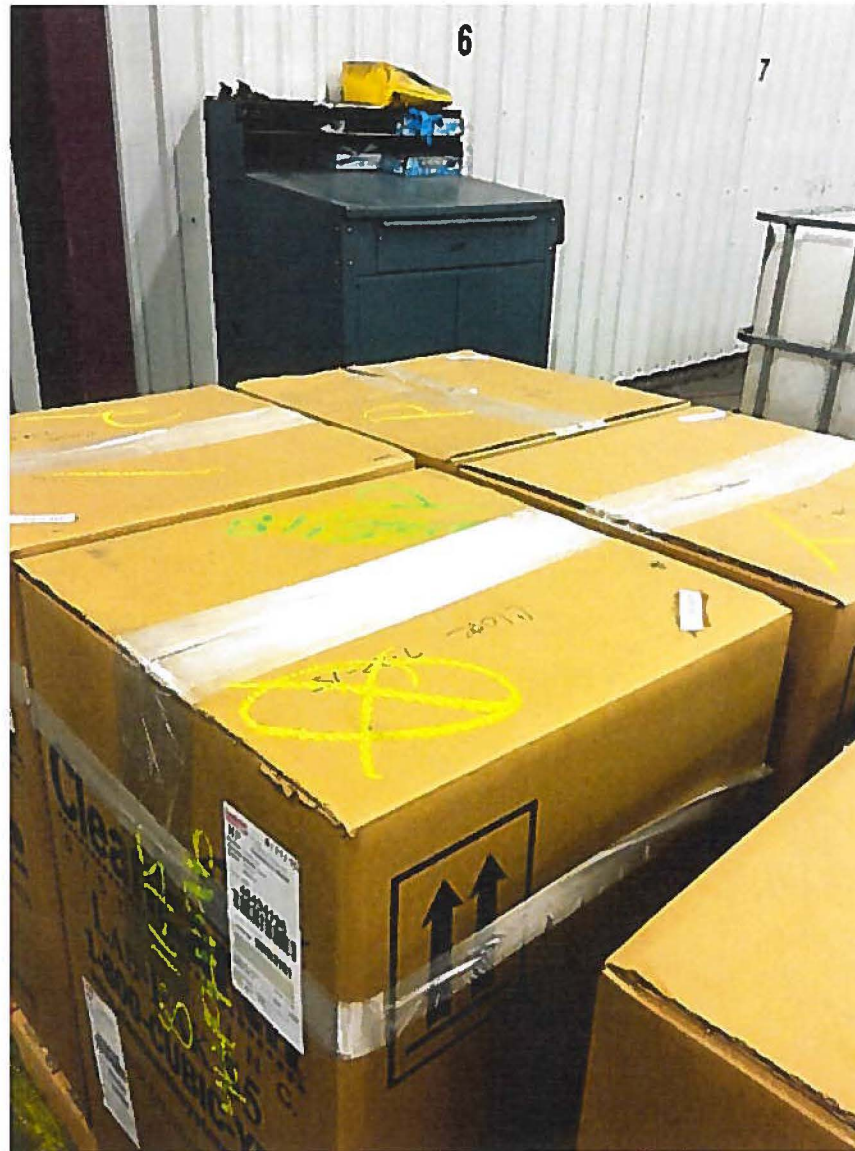
Figure 1: Taped box in Area 57C (Violation 1b)

CHESI Response: Action to close the containers was taken during the EPA inspection to fix both containers. A retraining document on container management procedures has been issued to all involved employees to prevent similar issues in the future. Figure 1 shows the picture of the cardboard box in indoor sorting Area 57C that was re-secured during the inspection. At the time of finding the box it was taped down in front of EPA Inspectors. The tarp that was collapsed due to heavy rains was also fixed upon finding the slipped tarp on the box in Area 50A in front of EPA Inspectors.

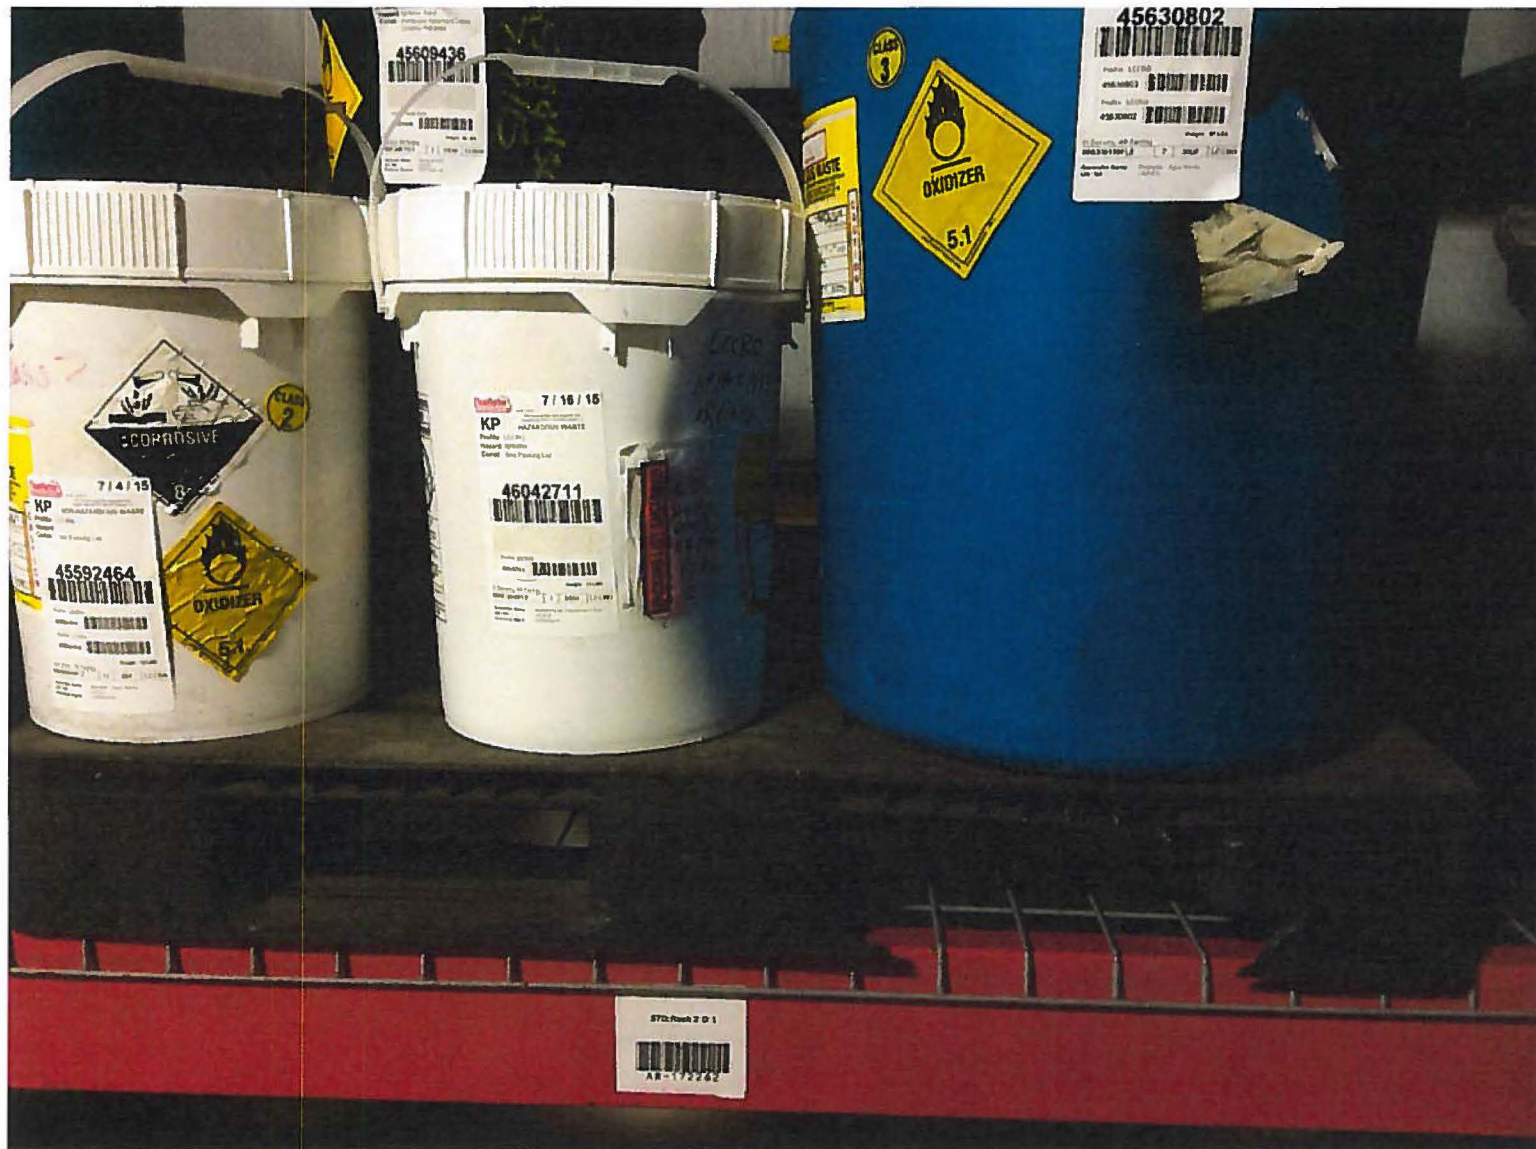
CHESI Response:
#46042711 - The suction of this bucket was released on August 18, 2015. This drum was shipped to Clean Harbors El Dorado, LLC for disposal on August 31, 2015. Figure. 2 shows this bucket with the suction released.

Figure 2: Suction Released from #46042711

Clean Harbors believes that the large fluctuations in temperature between cold nights and hot days caused the pails to concave. The box was inadvertently torn by a piece of equipment. All employees in the warehouse have been reminded of the obligations to ensure proper container integrity to prevent reoccurrence of these issues.

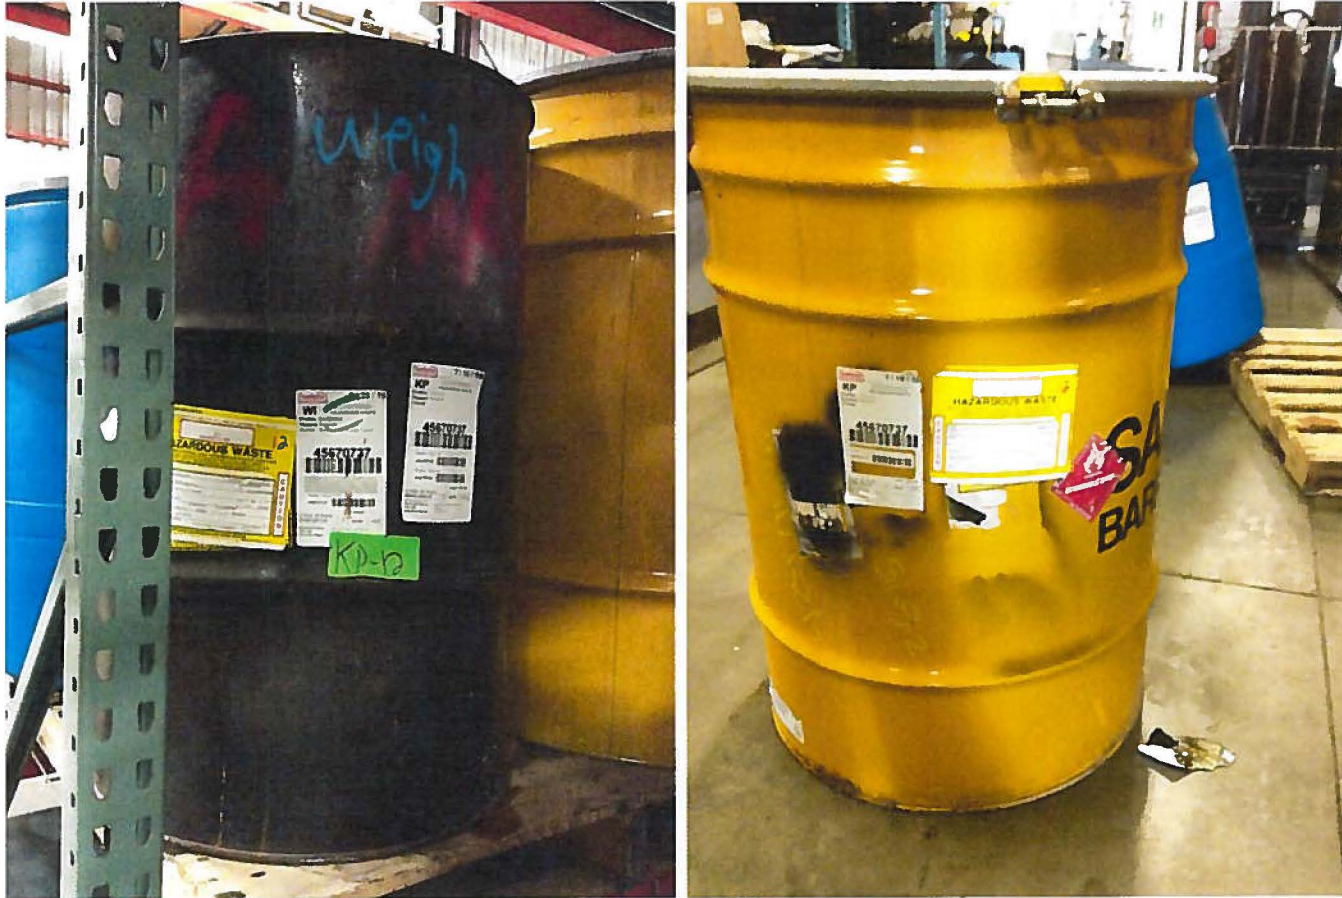
#45670737 – This drum was overpacked on August 18, 2015. CHESI does not believe that this container had a structural defect that affected the integrity of the container. Please see Figure 4 for a picture of the overpacked drum.

Figure 4: Overpacked drum #45670737

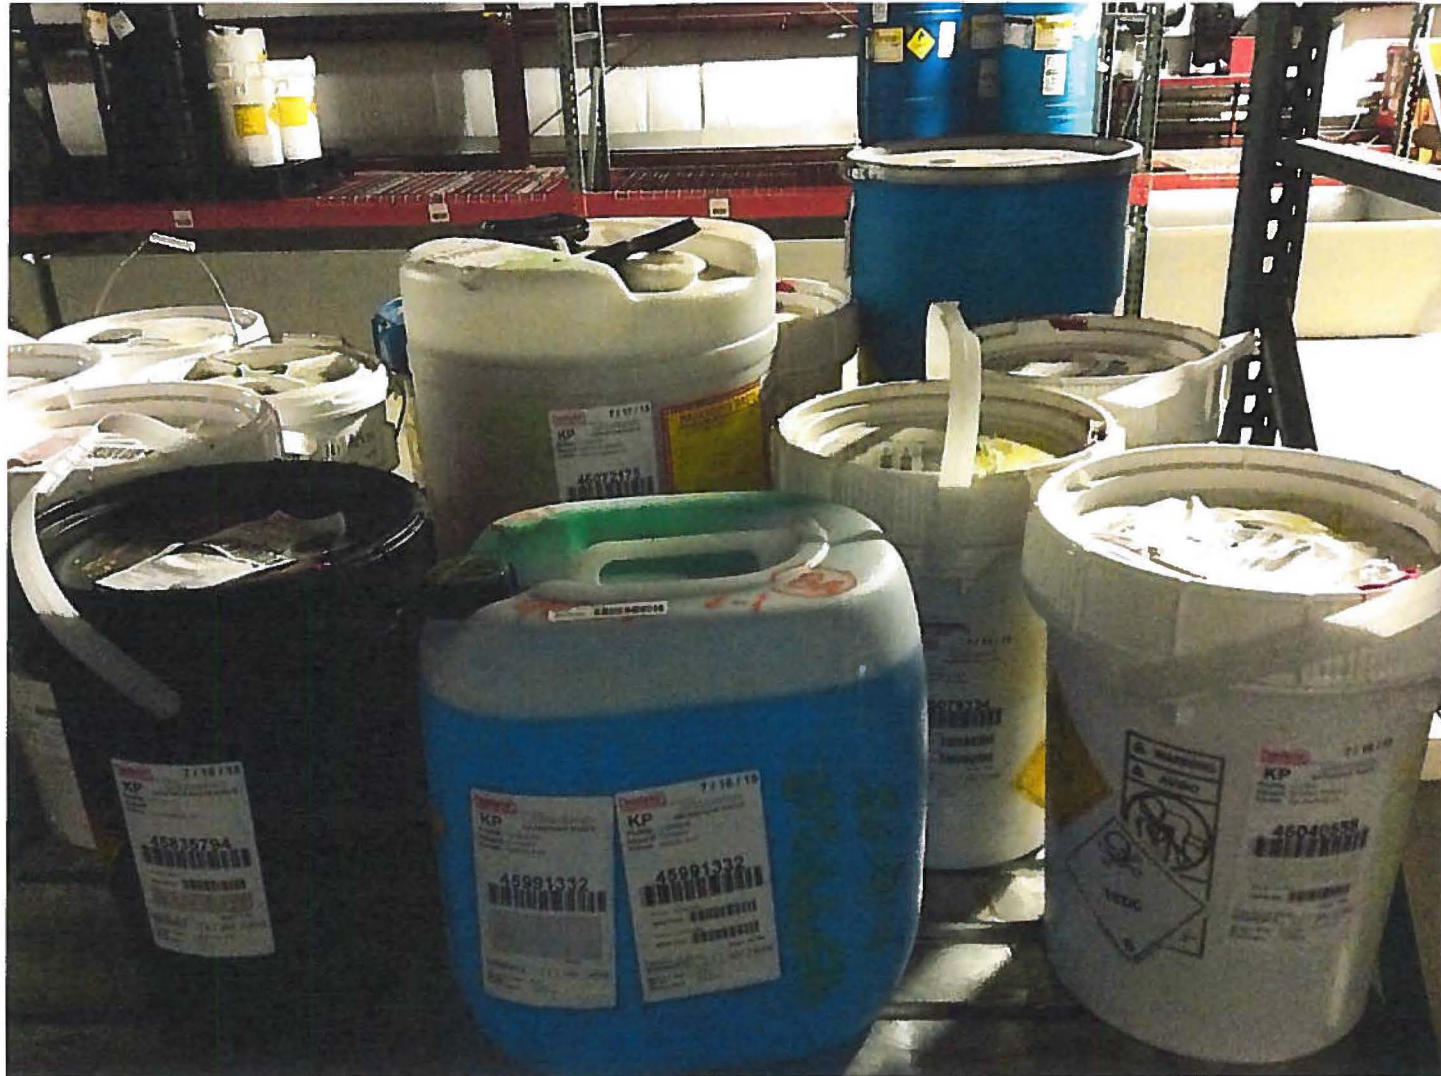
Violation 9 – Permit Condition III.F.2. – Unsecure pallet in Area 57D.

Figure 5: Rearranged Pallet in Area 57D

CHESI Response: The drums on the pallet in Area 57D were rearranged on August 18, 2015. Please see figure 5. A retraining document on container management procedures has been issued to all involved employees to correct similar issues in the future.
